Subject: Cylinder Block VIN Pad Reference Information

Ref: CB VIN 01V0

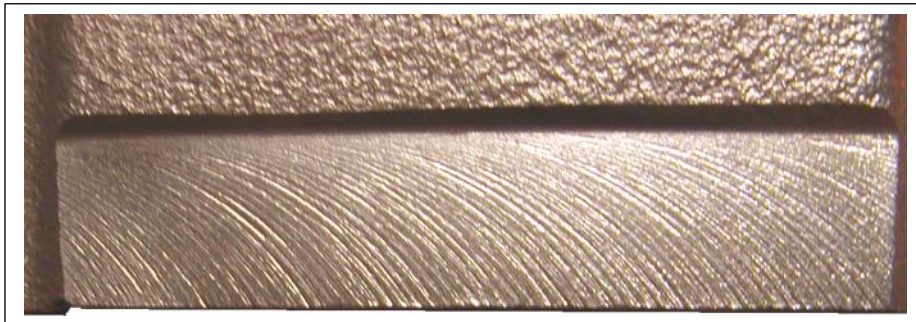
Typical unstamped VIN pad

In at least 98% of engines you should be able to see the cutter marks on the VIN pad. These marks on the pad were produced by a 10" inch diameter cutter. Even if the engine has the VIN number stamped on it the cutter marks should be visible. We have seen variations in the depth of the cutter marks. However, as stated 98% of the factory original untouched engines some cutter marks should be visible.

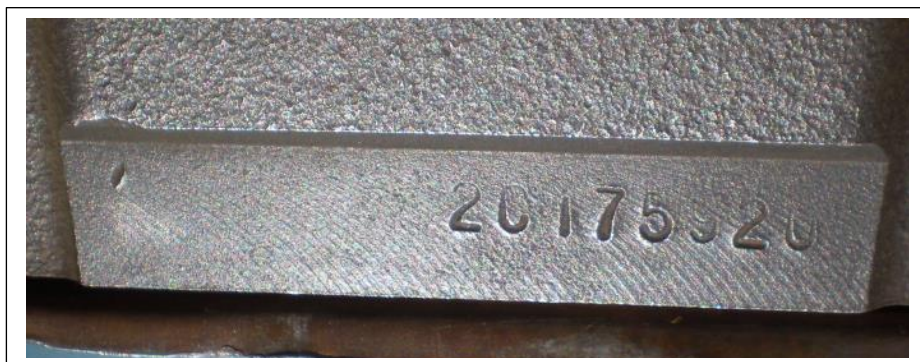
Light impact VIN stamp

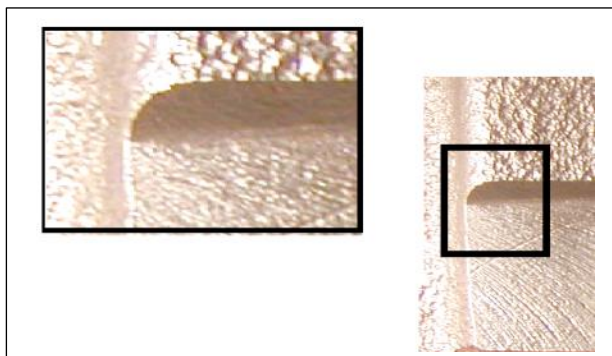
Note: When reviewing a suspect re-stamped and ground down engine ID pad you need to review the cutter profile at the very top of the ID pad. The original factory cutter has a very distinct profile.
